Bert Dijkstra and Stuart McIntyre

Besòs Long Sea Outfall, Barcelona

Abstract

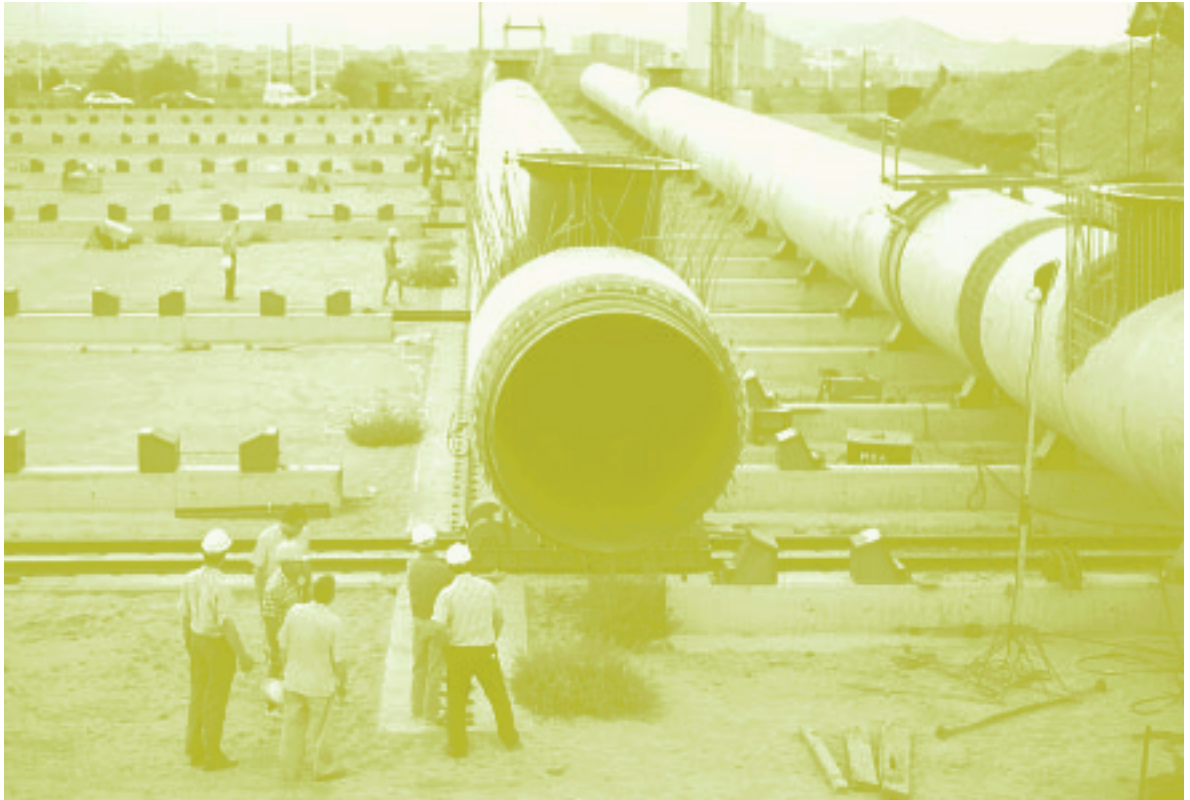
Figure 2. The first pipe string being moved from the welding area to the stock area. The structures on top of the pipe are the starters for the diffusers.

The strings were then moved sideways into stock and the joints between pipes completed with the concrete coating. The temporary works required to allow the handling of such large pipe strings was one of the major investments onshore; its successful operation determines whether welding is completed on time. Figure 2 shows the partially completed string number one about to be moved sideways into stock. During the welding and fabrication process, the offshore trench was being dredged. The dredging of the trench is the primary focus of this paper.

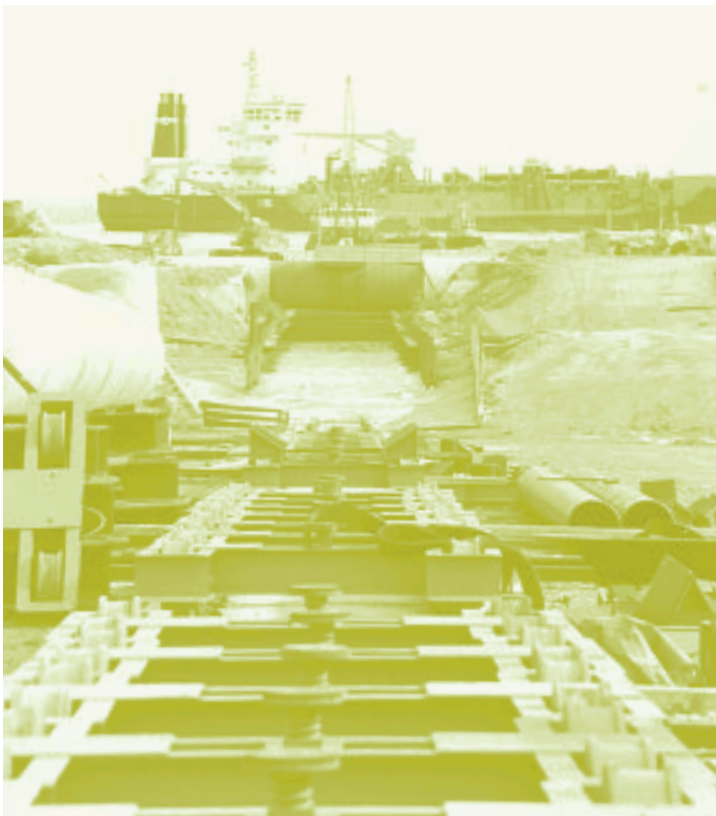
Figure 3. Cutter dredger Rozenburg, 160 m from cofferdam and hopper dredger Lelystad, 600 m from cofferdam, launching preparations on shore side.

Four different dredgers were utilised (Figure 3):

- trailing suction hopper dredger *Lelystad* to dredge up to 55 m below seabed;
- trailing suction hopper dredger *Poseidon* to facilitate backfilling of the trench through one of the suction pipes;
- cutter suction dredger *Rozenburg* to make the trench in the nearshore shallow waters; and
- submerged jetpump in combination with FLYGT pump (2 cutter system) operated from the pontoon *Kutxa* to allow for very accurate dredging near the existing pipeline.

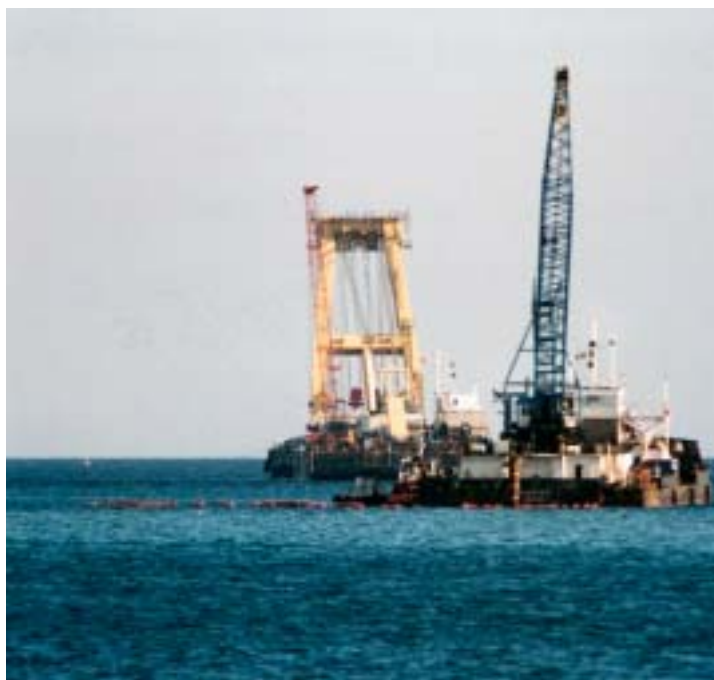
Figure 4. After backfilling, the area was compacted using twin torpedo vibro-compactors supported from the crane barge *Kutxa*. *Kutxa* is seen here dredging under the gas line, with a pull barge behind.

After backfilling, the area was compacted using twin torpedo vibro-compactors supported from the crane pontoon *Kutxa* (Figure 4), in a pattern that compacted 5 m² per point. Design of the soil improvement area to support the breakwater and protect the outfall, even during earthquakes, used specialist three-dimensional consolidation, finite element models developed by Cambridge University, followed by finite element dynamic earthquake analysis using real earthquake recordings, scaled appropriately to the design criteria at Barcelona.

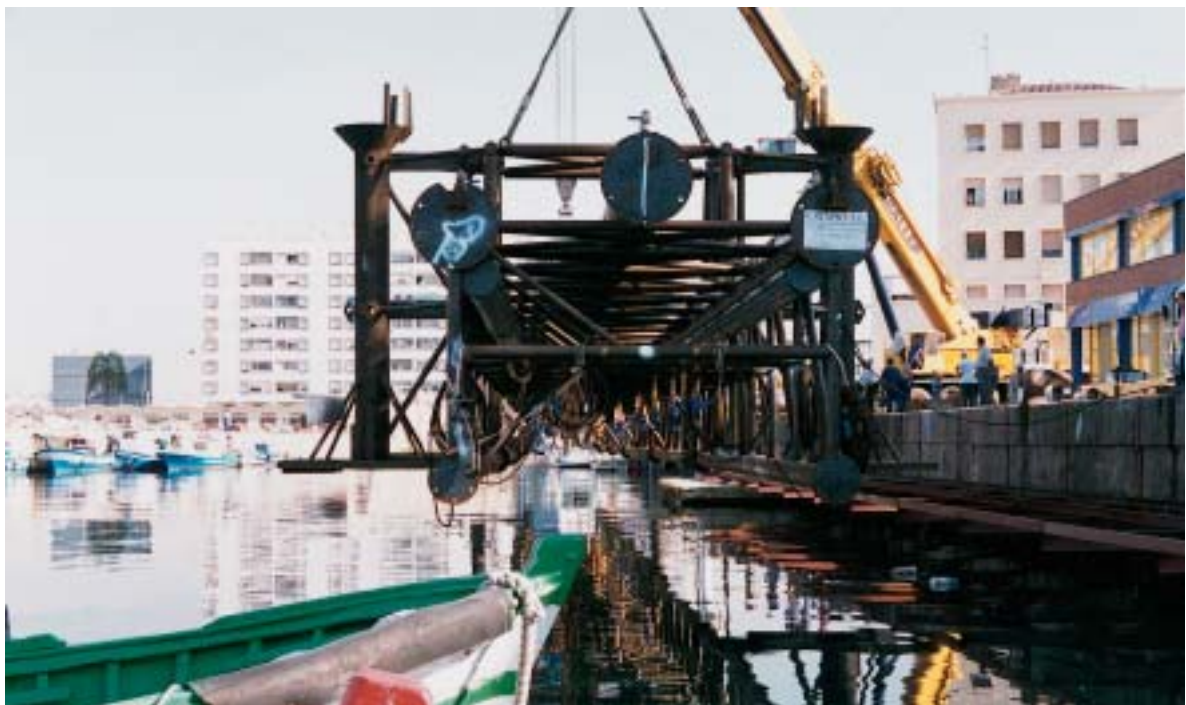
Figure 6. The gas pipeline bridge is lowered into the harbour in preparation for towing out to site. This support bridge is 60 m overall length.

around Barcelona, the gas line could not be shut down to allow dredging of the trench. It was therefore supported on a lattice 'bridge' with a length of 60 m and a clear central span of 40 m. The bridge was designed in accordance with API RP2A (Figure 6). Although this solution worked well, considerable restrictions were placed on dredging activities.

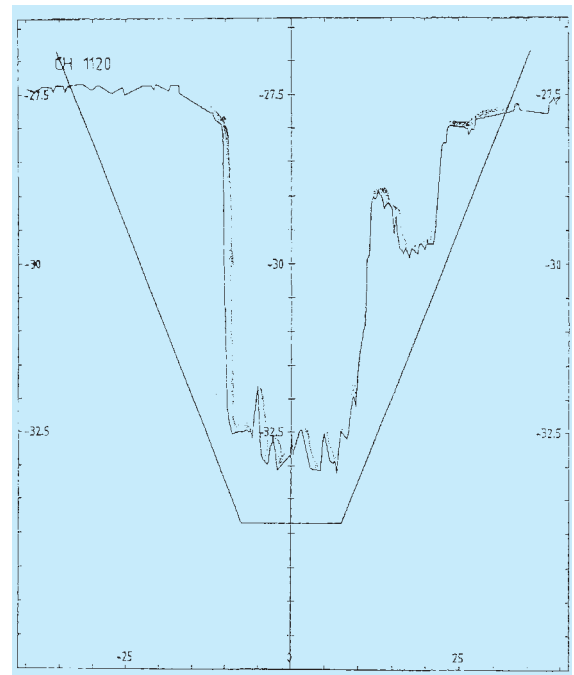
Figure 9. CH 1120 cross-section. Progress bridge 19 November 1994.

Because of the nature of the sandy clay encountered, excavation slopes were steep (approximately 1:1). This had the advantage of reducing the overall amount of material to dredge, but as the material was not free running towards the pump and cutters, every part of the required trench area had to be thoroughly covered by the cutters. Figure 9 shows the trench cross-section near the gas line. It makes clear just how steep the trench slopes were.

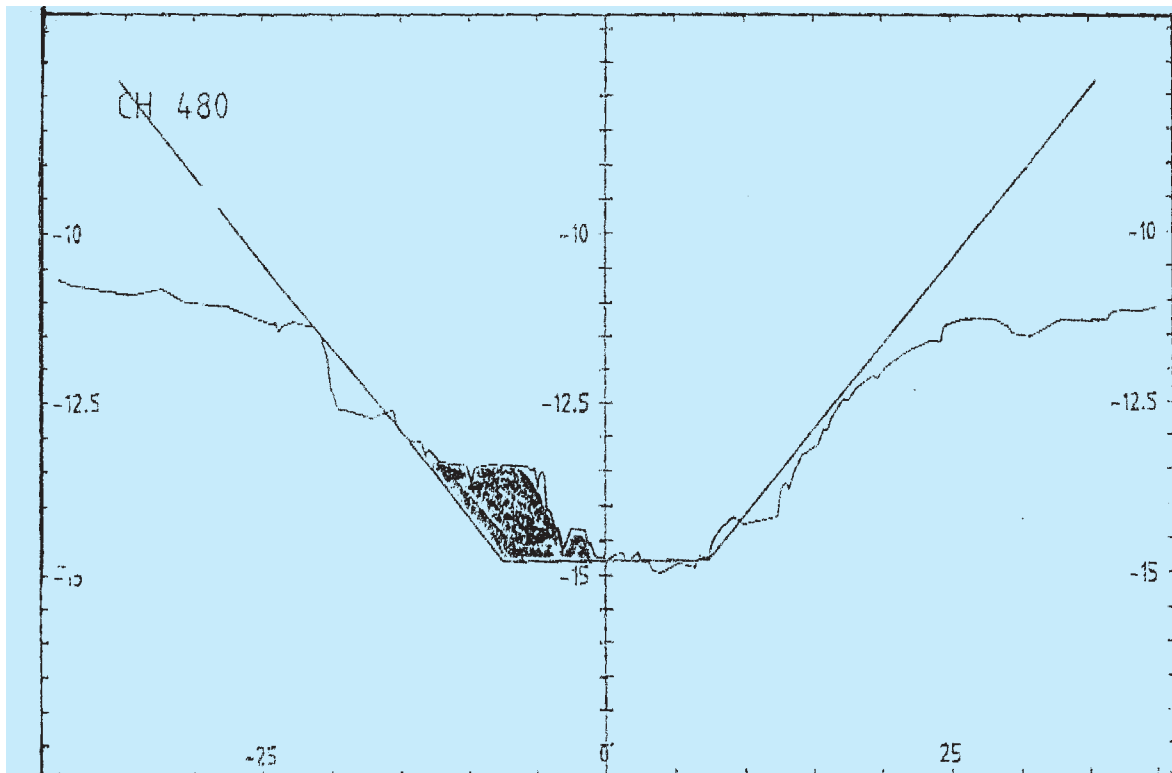
Figure 10. CH 480 cross-section. Preliminary outsurvey Kp 60-500, 15 November 1994, showing "hard spot".

A difficulty encountered in dredging section 2 was the presence of a “hard spot” in the trench at CH 480 (Figure 10). The difficulty with dredging such hard spots is that the suction head follows the path of least resistance, and the danger arises of overdredging one side of the trench and leaving the other side high. This again calls for experience and skill from the crew and the dredging engineer on the bridge.

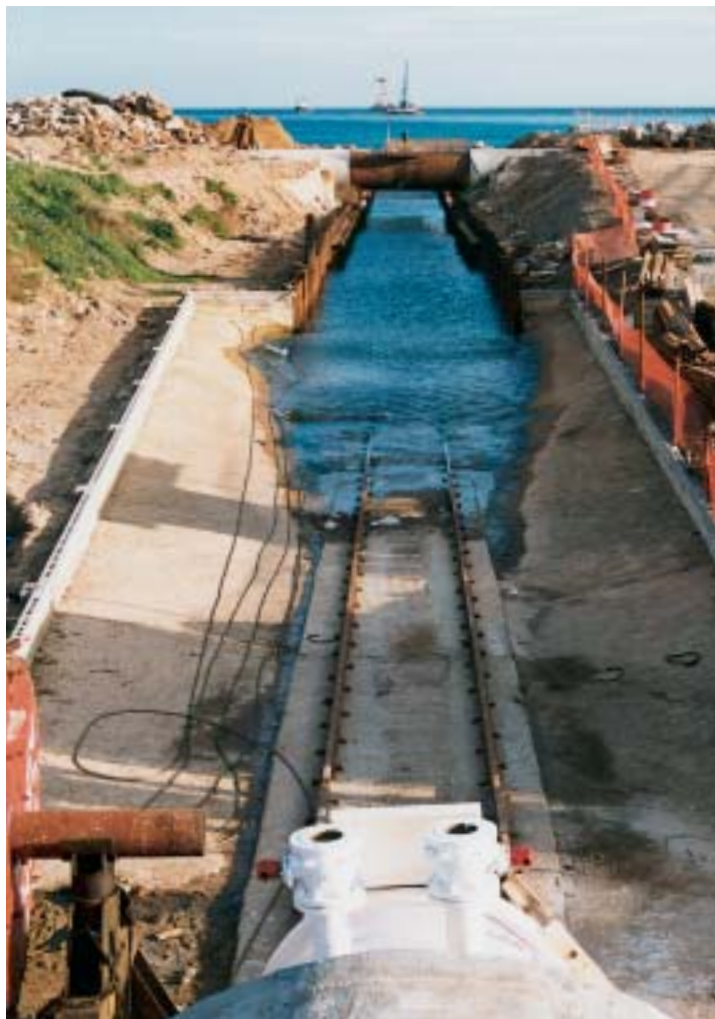
Figure 11. In the foreground, the pipeline is awaiting the pull. In the background is the pull barge and the pontoon dredging underneath the gas line. In the middle ground is a sewer diversion pipe crossing the pipe trench.

When dredging of the trench was complete and accepted by the client, the outfall could be pulled out. The pull out went very smoothly, with the outfall being pulled into the trench using the *Taklift 8* pull barge with an installed winch capacity of 600 tonne reacting against four huge anchors placed further offshore (13 Tonne Stevpris type). One 117 metre string was fully welded, wrapped, concrete coated and pulled out every 24 hours (Figure 11).

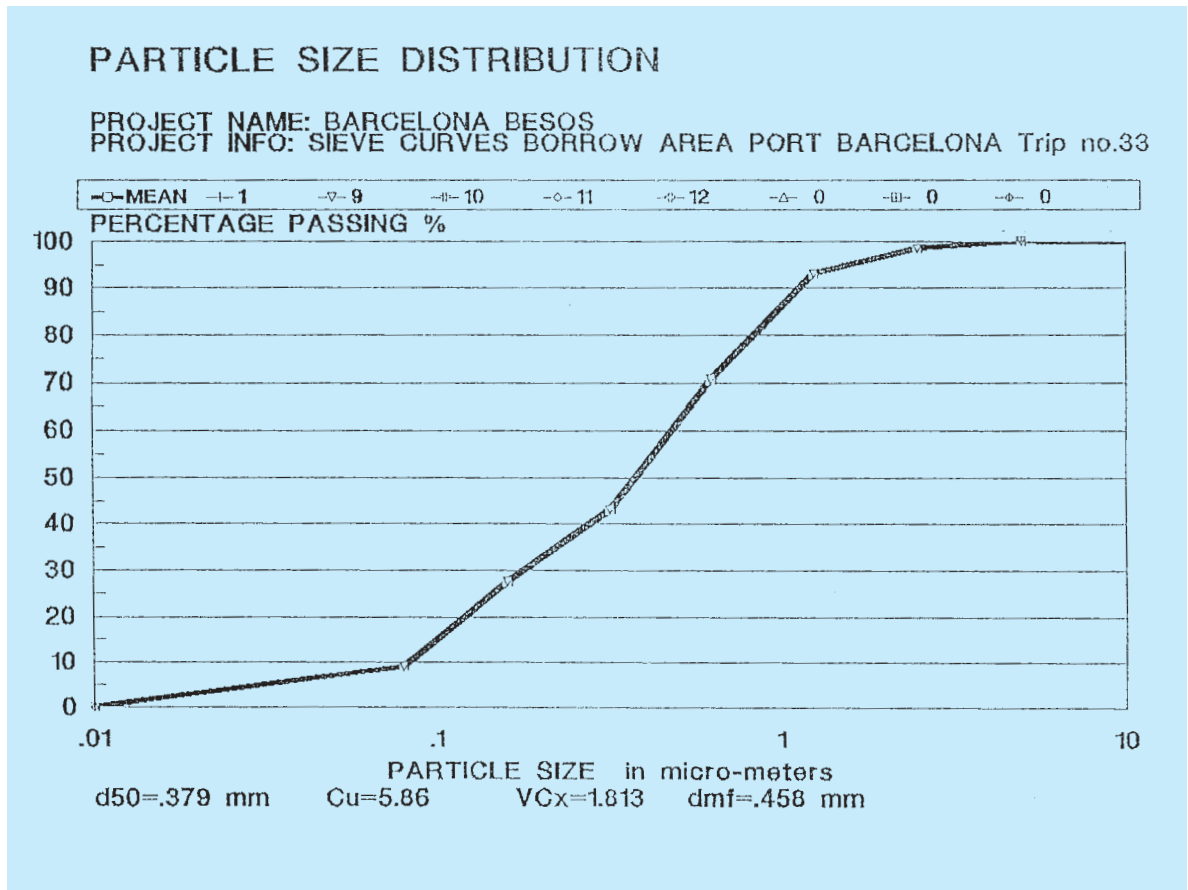
Figure 12. Particle size distribution of sand for backfilling.

row area was very limited and alternative borrow areas had to be located. The alternative sand source provided material of the grading shown in Figure 12.
